FORD RANGER ( 2022→ ...)

## INSTALLATION MANUAL

### CANOPY ACA STYLISH FORD P703 EU

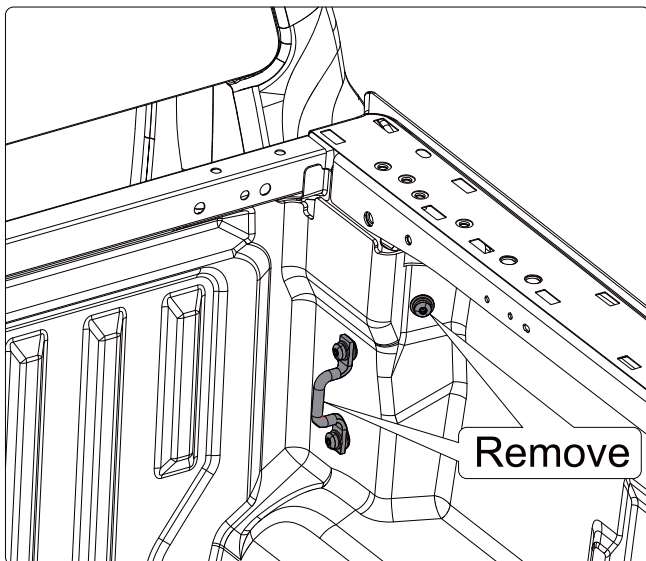
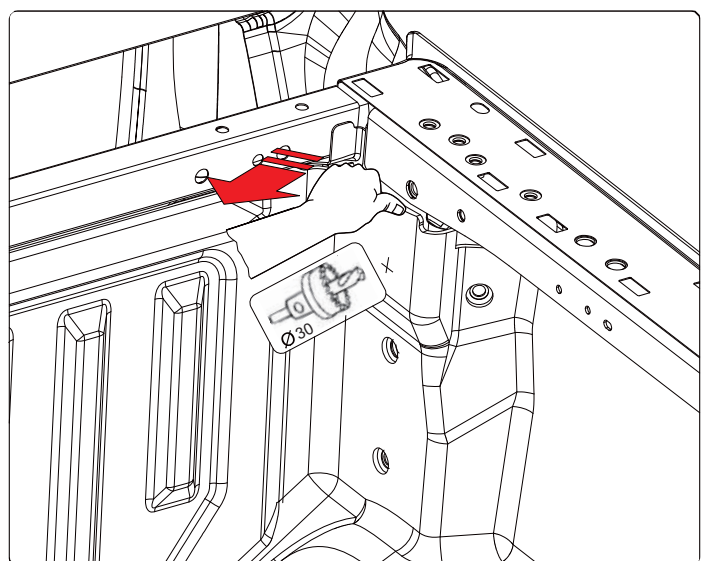
Add Isolation to protect tub paint

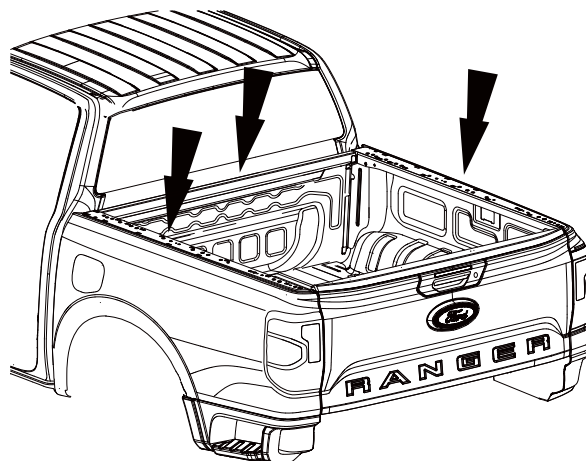
3

Added silicone to top of front corners. (LH and RH)

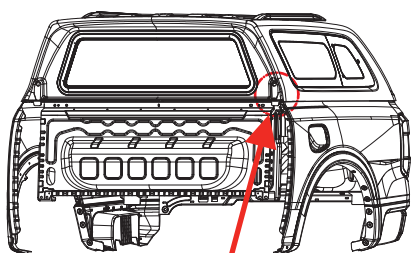
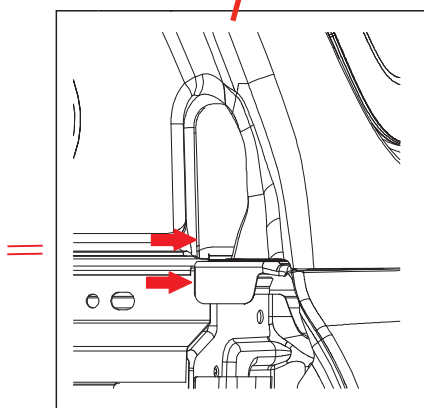
Minimum 25 mm.

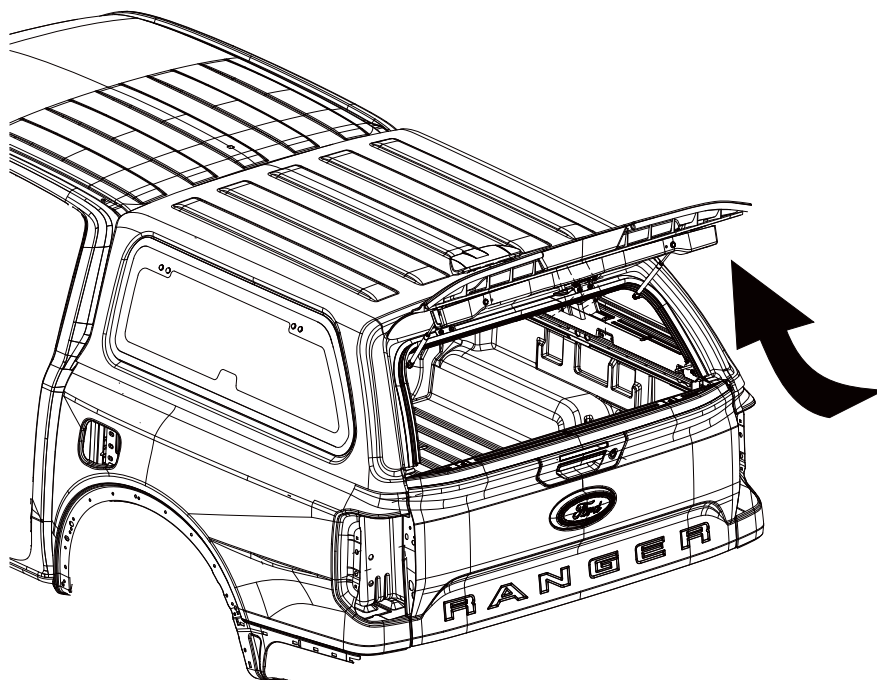
7

★ No. T40

25 $\pm$ 3 N.m.

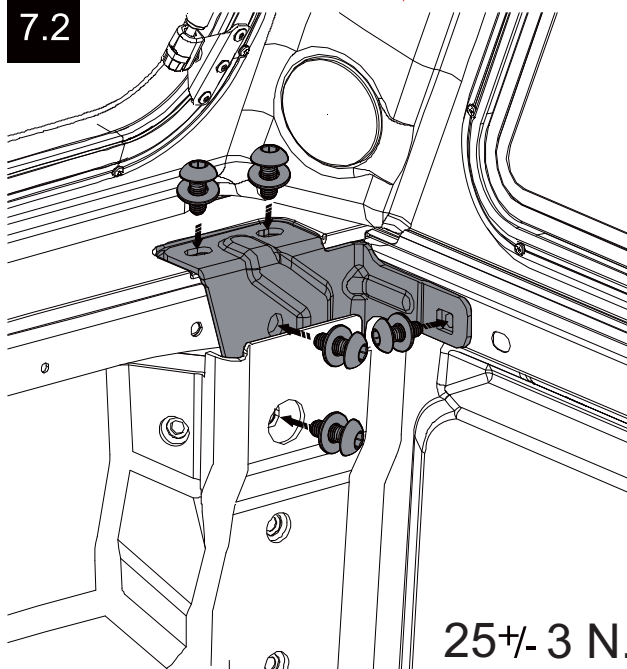
25 $\pm$ 3 N.m.

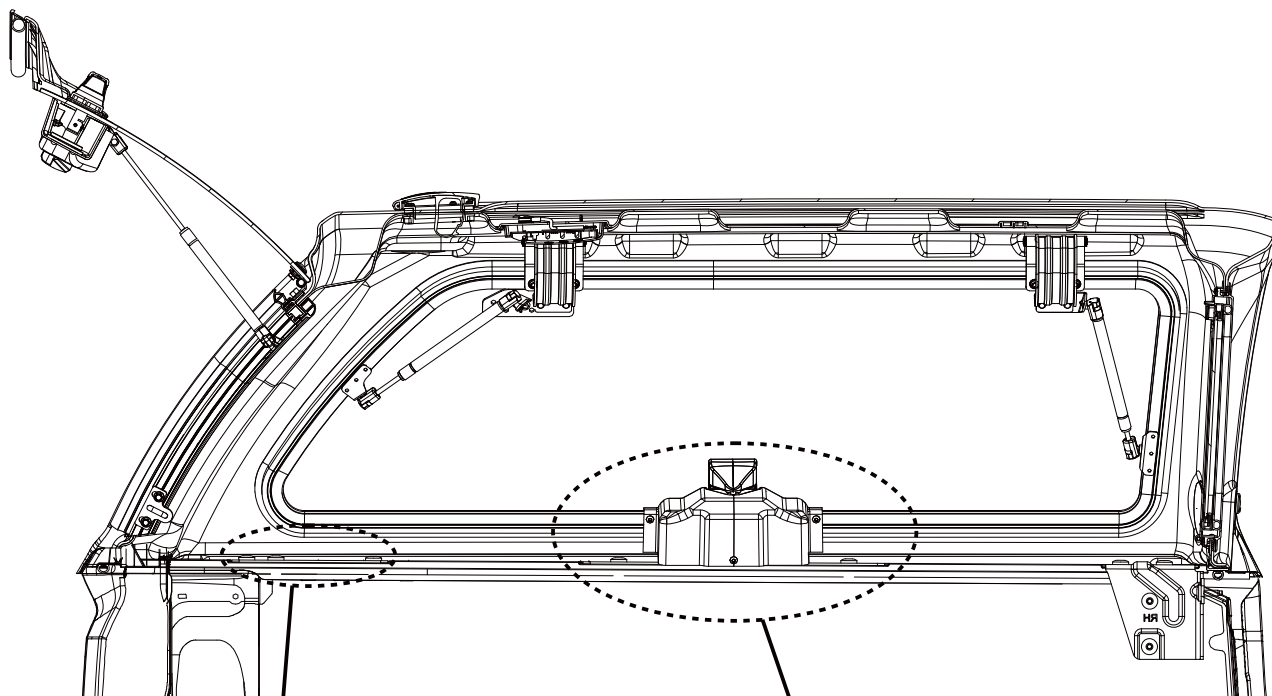
8

★ No.T40

25±3 N.m.

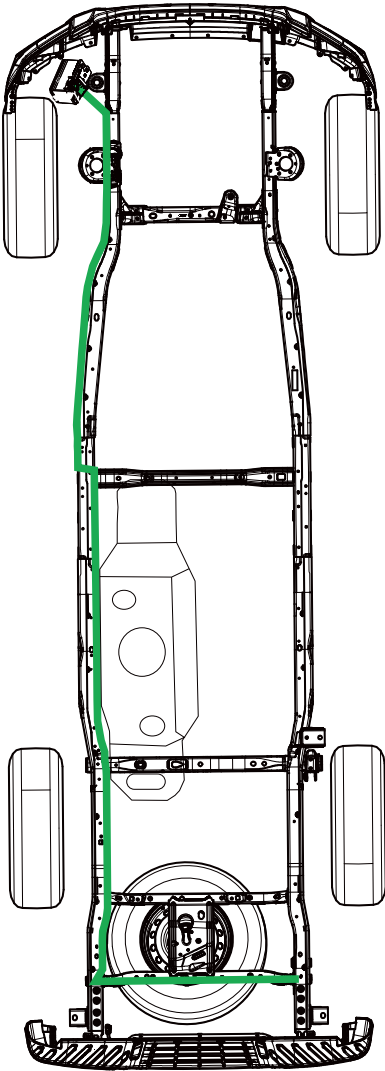
11

Canopy harness to follow to the main chassis wiring harness

Zip ties to be used every 300 mm. to secure the canopy harness to the chassis wiring harness.

Canopy harness to route over the spare wheel and fuel tank

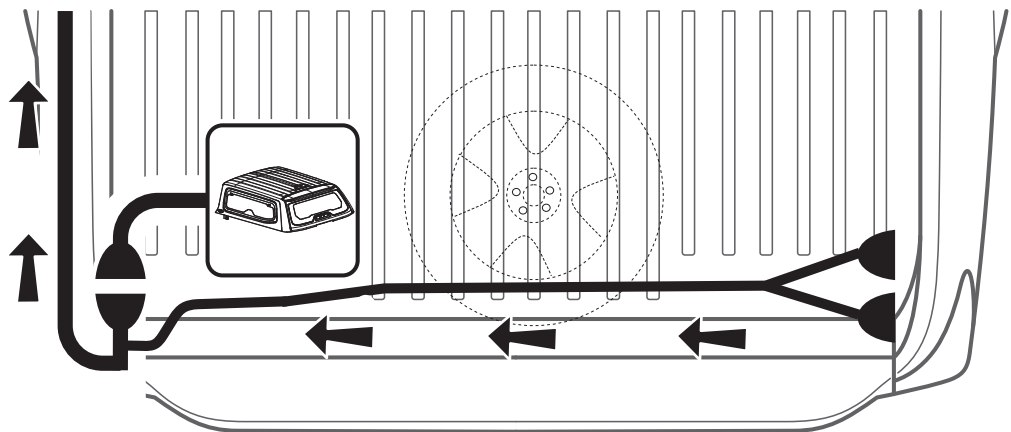
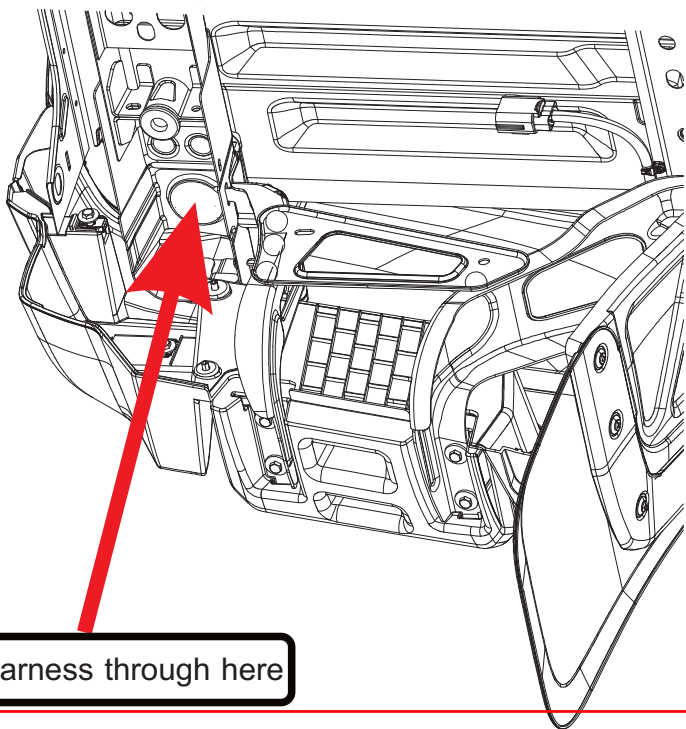
Remove Bolts.  
Do not disconnect lamp harness.

Feed canopy harness through here

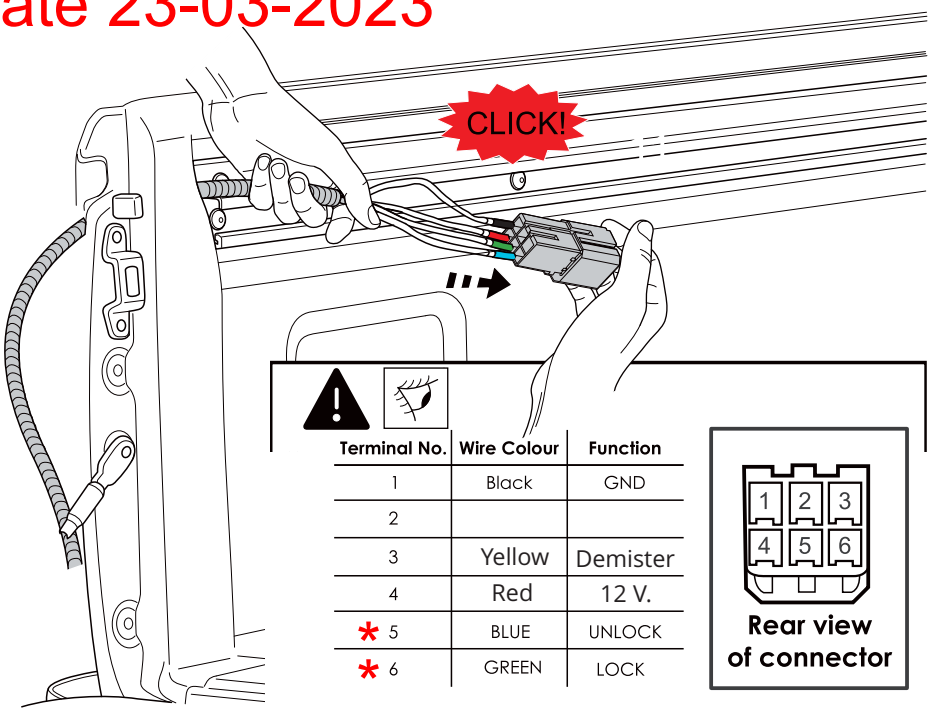
| Terminal No. | Wire Colour | Function |
| 1 | Black | GND |
| 3 | Yellow | Demister |
| 4 | Red | 12 V. |
| * 5 | BLUE | UNLOCK |
| * 6 | GREEN | LOCK |

Rear view of connector

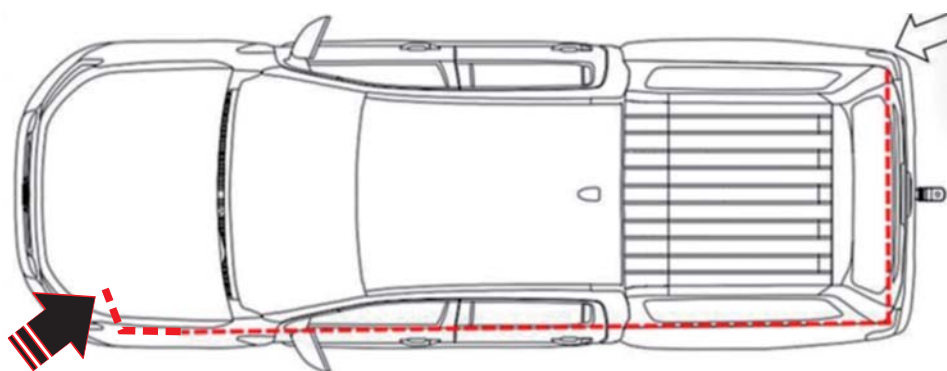
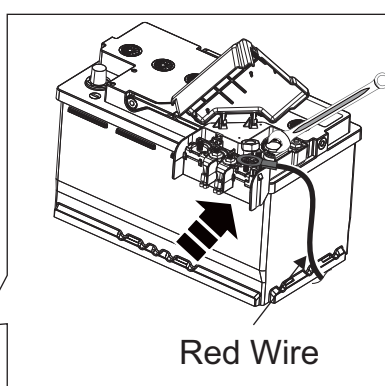
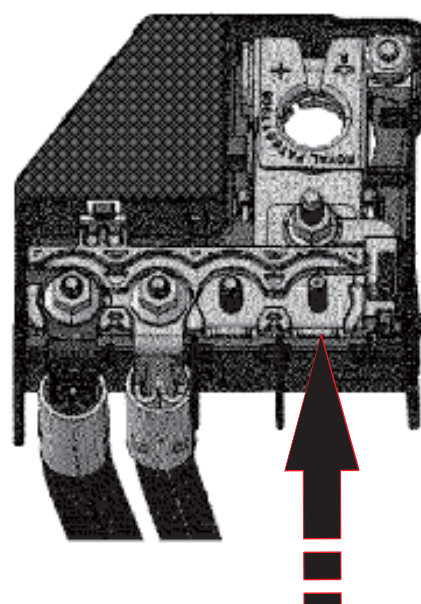
17

Use empty Terminal to connect ring connector and supplied nut. Torque 10Nm+/- 1.5Nm

FOR TT BUILDS – NUT NOT PROVIDED. USE EXISTING TERMINAL

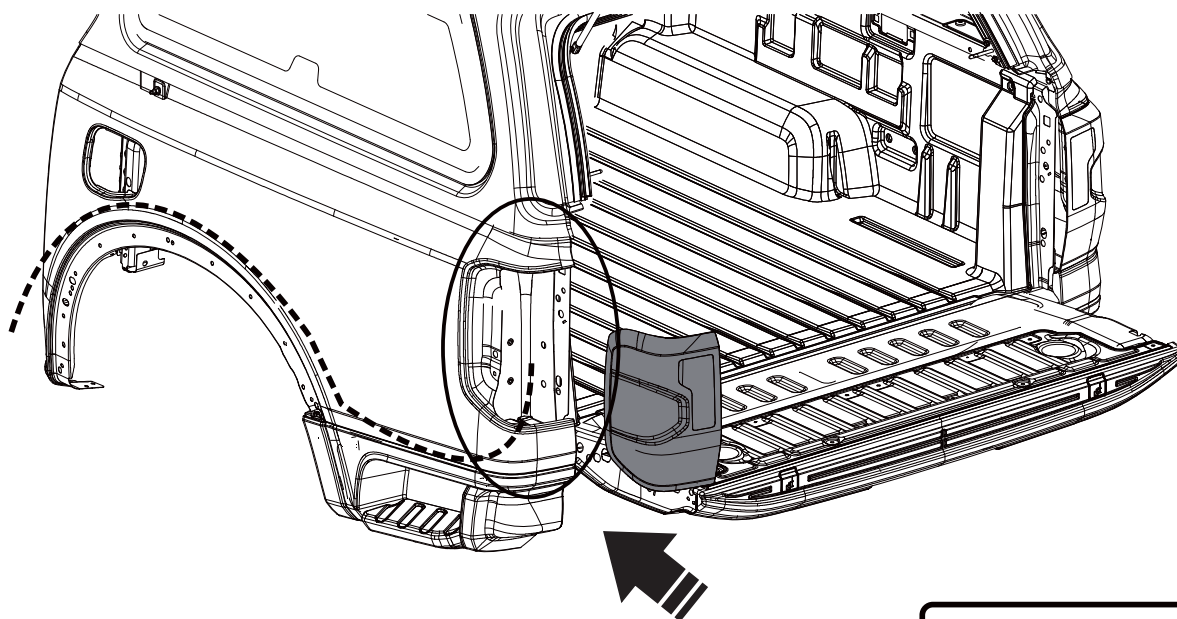
18

M6x16  
TORQUE 5.4 + 0.9 N-m.
